USG/Thermafiber

Address: **2301 Taylor Way, Tacoma**
 Region: **Hylebos Waterway, Commencement Bay**
 Designer: **AGI Technologies**
 Contractor:
 Owner: **Thermafiber LLC**
 Shoreline Type: **Industrial Canal**
 Project Type: **CERCLA Restoration
 Re-grade, Gabion Mattresses**
 Wave Energy: **Very Low**
 Tides: **MHHW: +11.84
 Extreme High: +14.9
 Extreme Low: -3.84**
 Cost: **N/A**
 Date Completed: **August 1997**

Project Description

Weather Watch Park

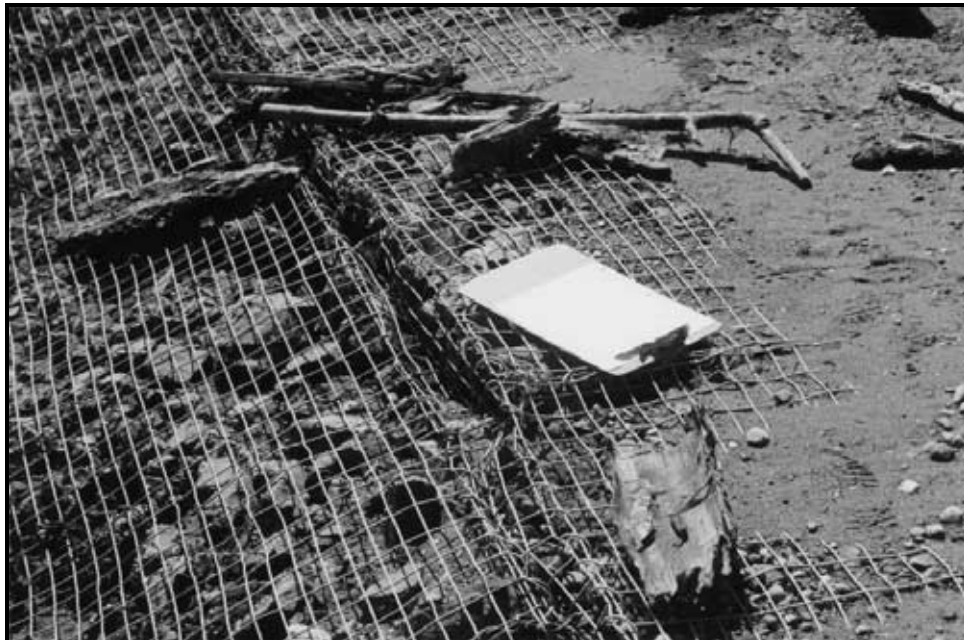
Figure 4. Detail at waterward edge of bench showing exposure of gabions.

No official monitoring plan is in place. A band of the gabions have become exposed since the project was finished. This area is approximately 8' wide and runs most of the width of the site. There has also been significant settlement by seaweeds on the exposed baskets.

The gabion baskets have been exposed on the waterward edge of the bench (Figure 4). This does not indicate any serious problem for the project, only that the intertidal slope may have been too steep. The geometry was constrained by the inflexibility in moving the shoreline landward and by space required by the bench itself.

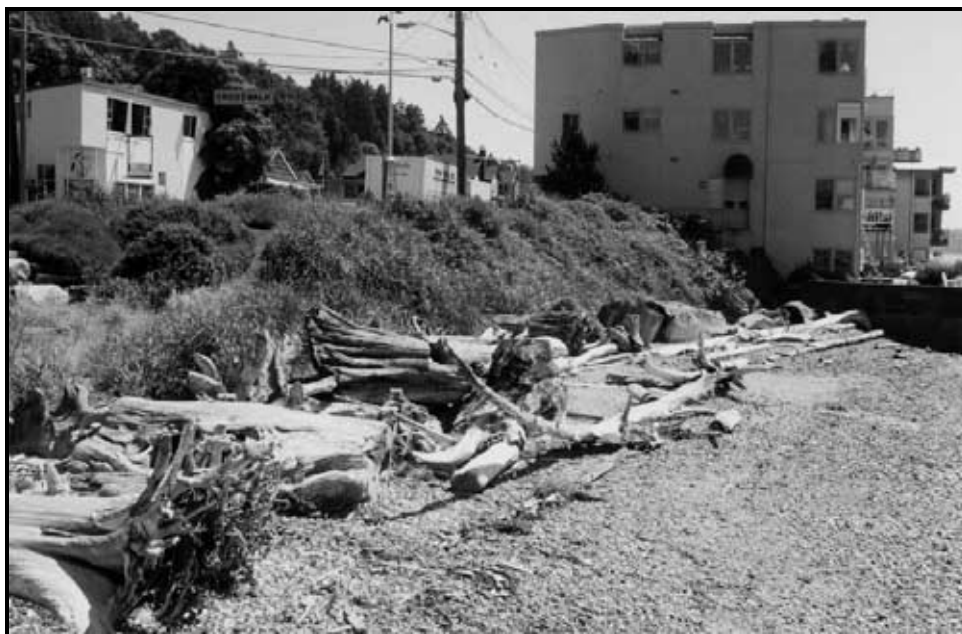
Figure 1. View south of Weather Watch Park. Note vegetated bank and drift accumulation along berm

Weather Watch Park is not an example of a project designed to resist erosion as much as one designed to avoid erosion. The project began by removing rubble that had accumulated on site over the course of seventy years as a vacant lot. The bank was not regraded or reconstructed -- it was only reinforced with several large rocks. The woody debris was not placed on site -- it is what accumulated naturally in the pocket beach. Once the bank was cleaned up, extensive revegetation was performed. Paths down to the beach were built and a park like atmosphere was created in a small area at the street level.

The entire project is set at least 30' farther back than the vertical cement bulkheads on either side. This is a significant factor contributing to the effective accumulation of sediments and drift logs, as well as the protection of the bank itself from wave erosion.

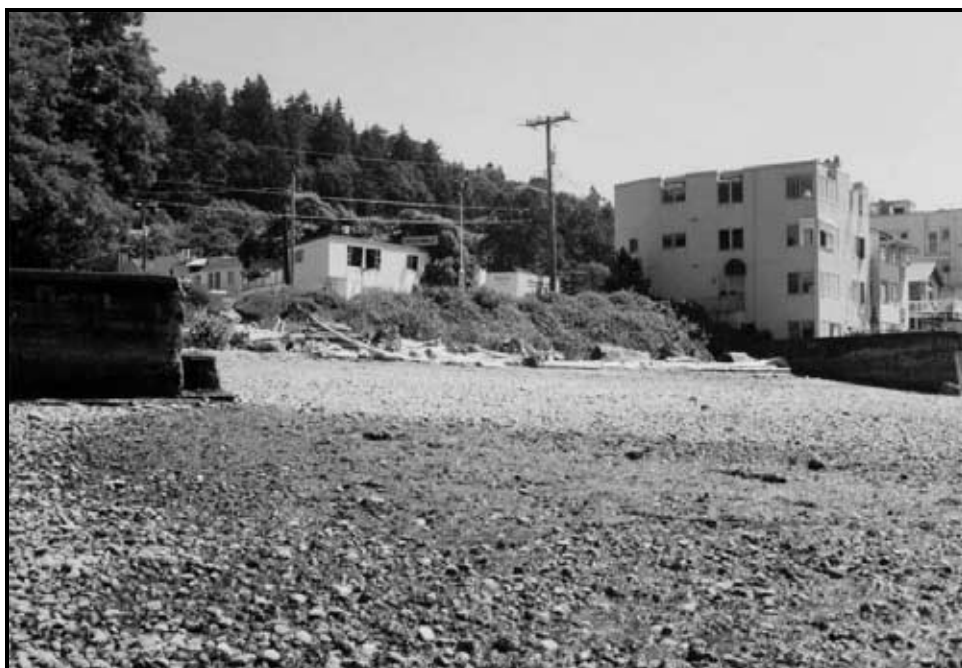
Figure 2. View of park illustrating adjacent bulkheads. This photo emphasizes why it is difficult to restore, or maintain, natural beaches when human action has encroached into the intertidal.
